Professional Building Inspection Service

1234 Elm St. Denver, CO

Date Inspected:
June 5, 2010

Inspection Address: 1234 Elm St
Report Number:

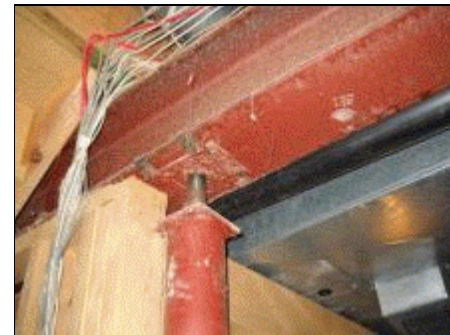
The construction of the house is of average quality with typical liberties taken with good building practice and with the quality of materials employed. The inspection did not disclose significant deficiencies in the structure. The foundation and other visible elements of the underbuilding support structure were generally in satisfactory condition for the age of the dwelling. However, we suggest attention to the items noted below. **Finished areas and storage restricted the inspection of the foundation and basement. The basement has been finished. Recommend verifying that the proper permits and inspections have been completed.**

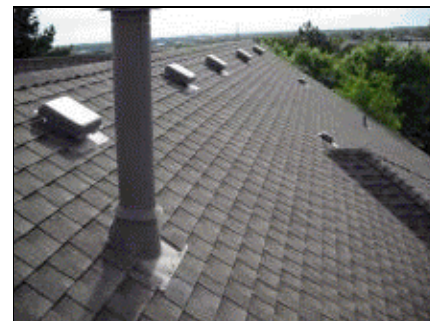
The roof coverings are considered to be in generally good condition. In all, the roof coverings show evidence of normal wear and tear for a home of this age. Some typical indicators of aging (such as minor surface cracking and slightly raised seams) were visible. However, the wear is consistent over the entire surface and typical for a cover this age. The steep pitch of the roof should result in a longer than normal life expectancy for roof coverings. Trim away tree branches close to the roof.

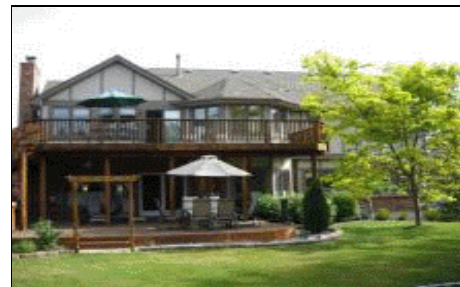
The exterior of the home is generally in good condition. The exterior of the home shows normal wear and tear for a home of this age. There is no significant wood/soil contact around the perimeter of the house, thereby reducing the risk of insect infestation or rot. The auto reverse mechanism on the overhead garage door responded properly to testing. This safety feature should be tested regularly as a door that doesn't reverse can injure someone or fall from the ceiling. Refer to the owner's manual or contact the manufacturer for more information.

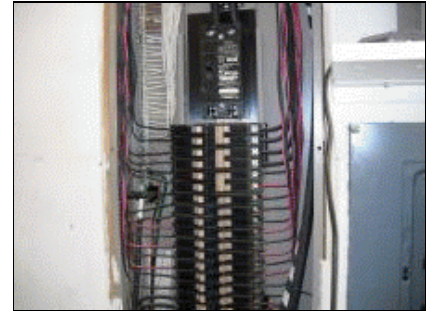
The size of the electrical service is sufficient for typical single family needs. The electrical panel is well arranged and all fuses/breakers are properly sized. Generally speaking, the electrical system is in good order. Inspection of the electrical system revealed the need for typical, minor repairs. Although these are not costly to repair, they should be considered a high priority for safety reasons. **Unsafe electrical conditions represent a shock hazard.** A licensed electrician should be consulted. Evidence of remodeling or modifications to the electrical system were evident at the time of the inspection. We Recommend inquiring with the owner as to the nature any permits and/or inspections that may have been required. Evaluation of permits, identifying the extent of the modifications and code compliance are beyond the scope of this home inspection.

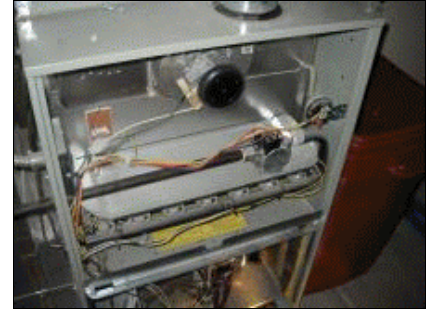
This is a relatively new system that should have years of useful life remaining. Regular maintenance will, of course, be necessary. The heating system is in generally good condition. The heating system is controlled by a “set back” thermostat. This type of thermostat will reduce heating costs. The furnace is a newer unit. Recommend verifying that the proper permits and inspections have been completed. The typical life expectancy for heating units is approximately 25 years. Some will last longer others will fail prematurely.

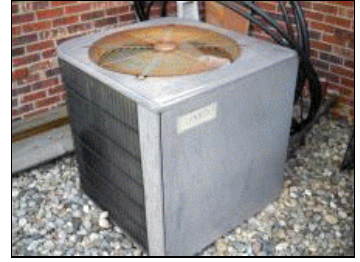
As the system is old, it will require repairs or replacement soon. This system has not been maintained. The system responded properly to operating controls. The typical life expectancy for AC units is approximately 25 years. Some will last longer others will fail prematurely.

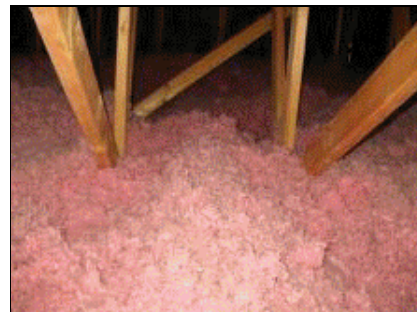
Insulation levels are typical for a home of this age and construction. Upgrading insulation levels in a home is considered an improvement rather than a necessary repair. Caulking and weather-stripping around doors, windows and other exterior wall openings will help to maintain weather tightness and reduce energy costs.

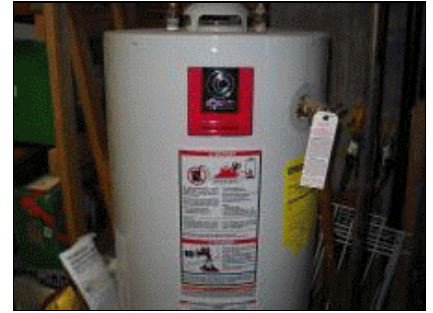
The plumbing system is in generally good condition. The water pressure supplied to the fixtures is reasonably good. A typical drop in flow was experienced when two fixtures were operated simultaneously. The plumbing fixtures are old. Upgrading fixtures would be a logical long term improvement. In the interim, a higher level of maintenance will likely be required. The water heater temperature should be set such that accidental scalding is minimized. Families with small children should be especially aware of this.

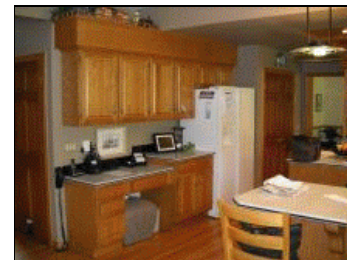
On the whole, the interior finishes of the home are in above average condition. Typical minor flaws were observed in some areas. The majority of the doors and windows are average quality. The floors of the home are relatively level and walls are relatively plumb. The appliances are middle aged. As such, they will become slightly more prone to breakdowns; however, several years of serviceable life should remain.
